Property Inspection Report

Inspection Address
1234 Any Street
Oakland, CA 94619

January 1, 2016

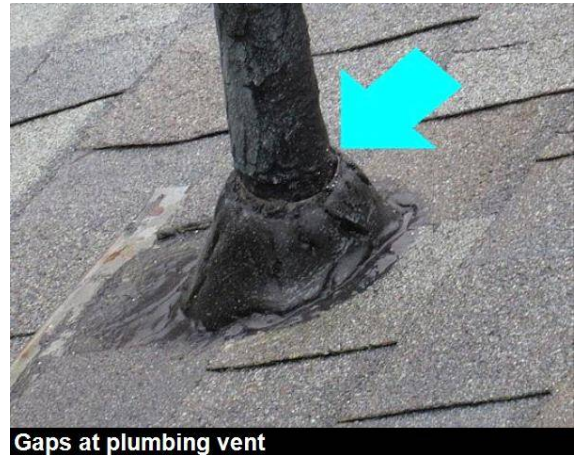
PIPING PENETRATIONS

A piping penetration at the right front is not adequately sealed and we recommend the penetration flashing be sealed as needed by a qualified contractor.

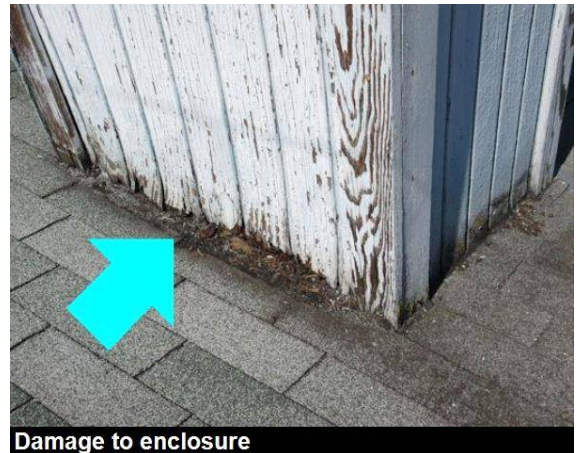
There is a wood-sided flue enclosure at the rear.

The enclosure siding is damaged and we recommend it be repaired or replaced as needed.

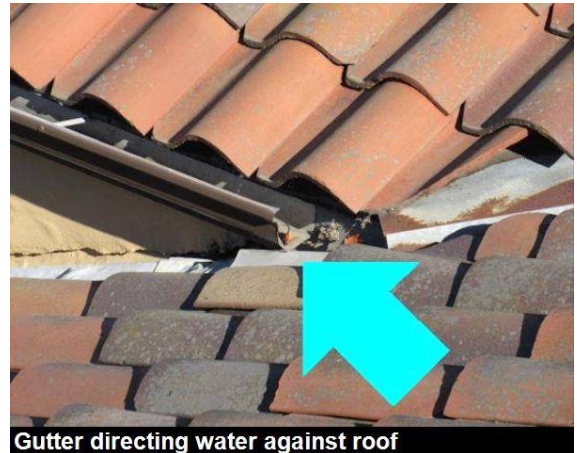
There are separations between the rain gutters and roof eaves. We recommend proper flashings are installed between the rain gutters and the roof edges as needed.

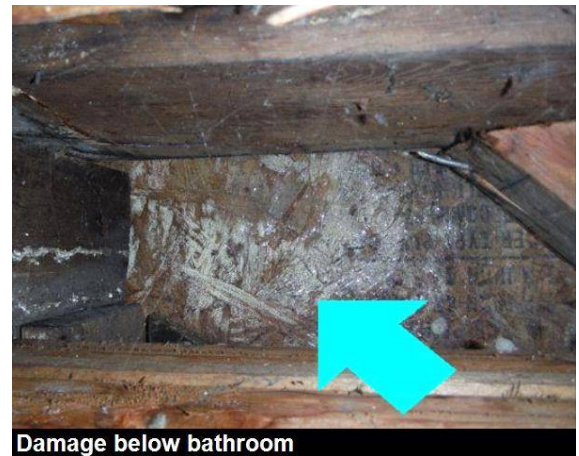
The subfloor area framing below the bathroom is damaged. We recommend the damaged wood be reviewed and replaced as needed by a qualified contractor.

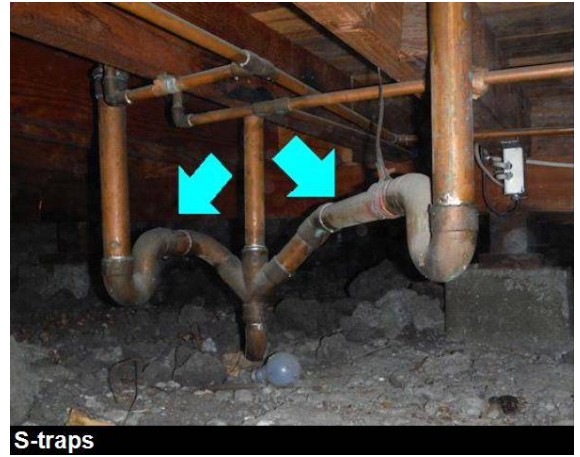
The hallway bathroom sub-floor area waste piping has S-traps, which are an improper configuration. We recommend this piping be properly installed by a qualified plumber.

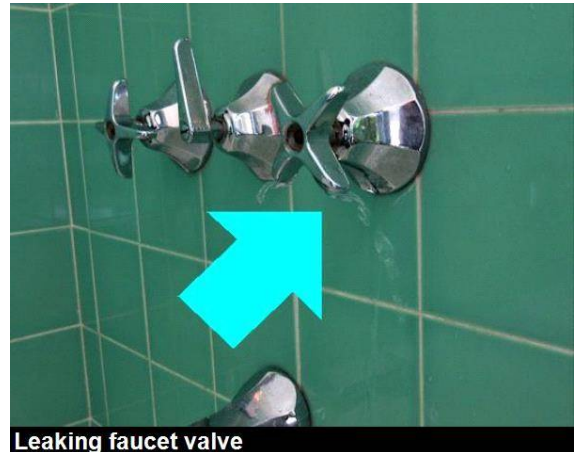
The tub hot water faucet leaks and we recommend it be repaired.
