# 4- Point Insurance Inspection Form

1.1 Name: Mr. and Mrs. Owner  
1.2 Address: 123 First Street  
1.3 City: Anywhere  
1.4 County: San Mateo  
1.5 State: CA  
1.6 Zip Code: 94510  
1.7 Inspector: Keith Tarkington, Tarkington Home Inspections, 510-566-2195, inspector@thinow.com  
1.8 Inspection Date: January 15, 2025

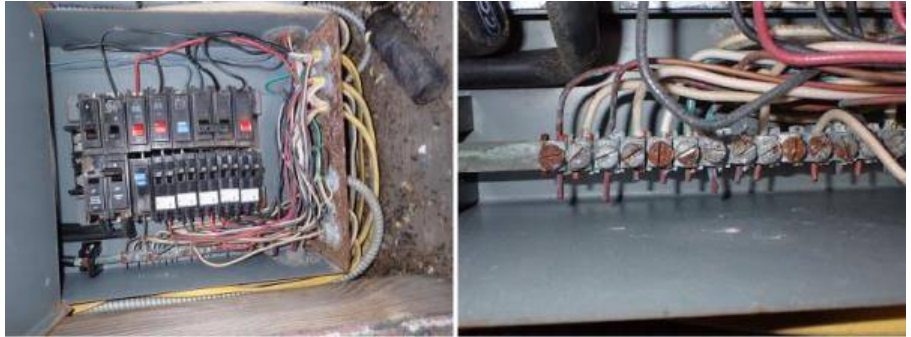
2.8 Panel Rating: 100 Amps  
 2.9 Age: Original to house  
 2.10 Panel Ground Observed: Yes  
 2.11 Hazardous Concerns: no cover, corroded  
 2.12 Panel Condition: Unsatisfactory  
 2.13 Photos 1:

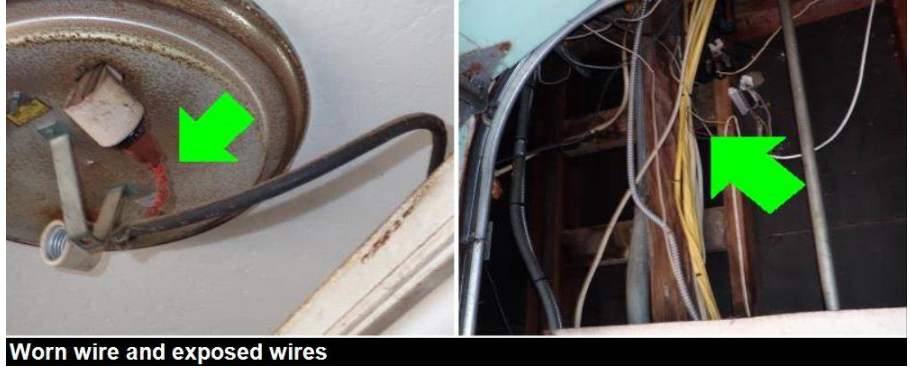
2.20 Photos 1:

2.14 Visible Branch Wiring: Romex, BX, Conduit, Knob & Tube,  
 2.15 Wiring Upgraded: Partial  
 2.16 GFCI Locations: Kitchen, Bathrooms, Garage,  
 2.17 AFCI Locations: None  
 2.18 Wiring Hazards: Exposed Wiring, garage light wire worn  
 2.19 Wiring Condition: Satisfactory

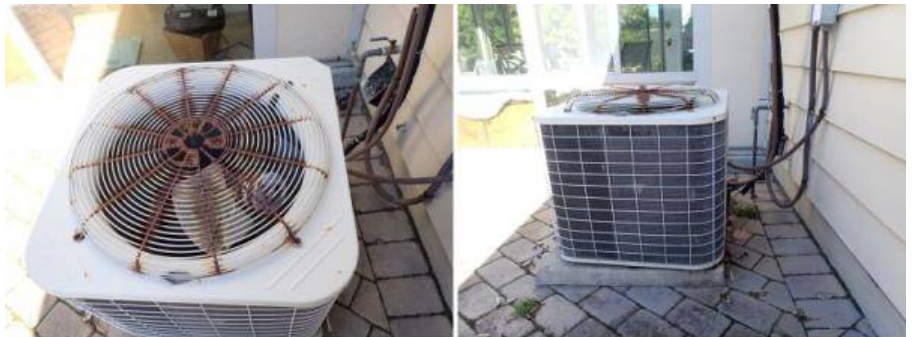
3.20 Photos 1:

3.19 Condition: rusty, disconnected

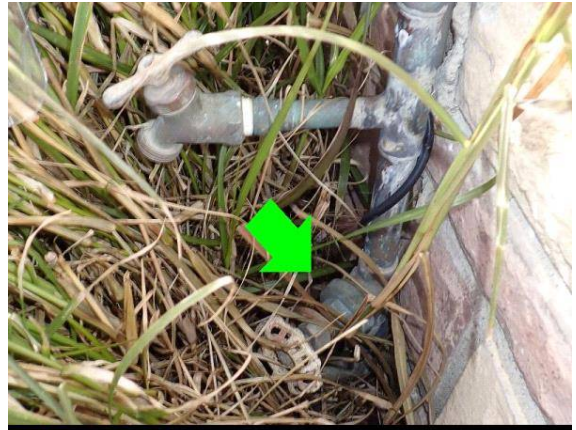
Main water valve

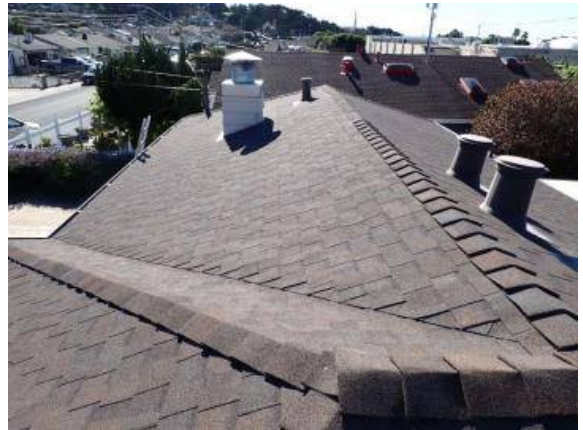
- 5.1 Roof Material: Composition Shingle  
5.2 Approximate Age: 1-5 years  
5.3 Estimated life expectancy: 20+ years  
5.4 Roof Shape: Hip  
5.5 Overall Condition: Satisfactory  
5.6 Evidence of active leaks: No  
5.7 Sheathing Material: Skip Sheathing, Plywood,  
5.8 Roof Damage: Exposed Nails  
5.9 Photos Front:
