Foundation Inspection Report

Prepared for
Mr. and Mrs. Owner

Inspection Address
123 Anywhere St
Concord, CA 94520

February 5, 2025

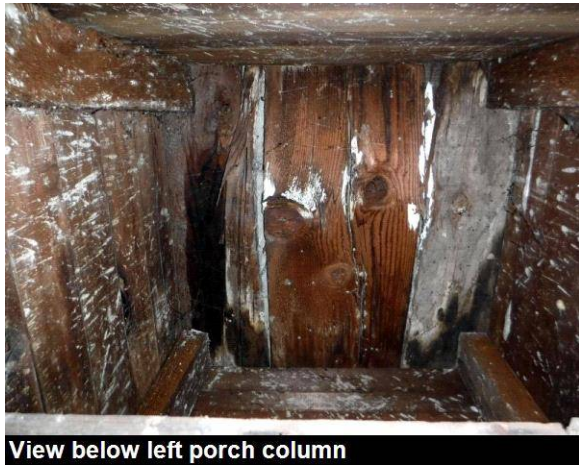
2.1 PORCH GENERAL

There is a wood framed porch at the front. It is in worn to poor condition.

The bases of several roof support posts are damaged and we recommend repair.

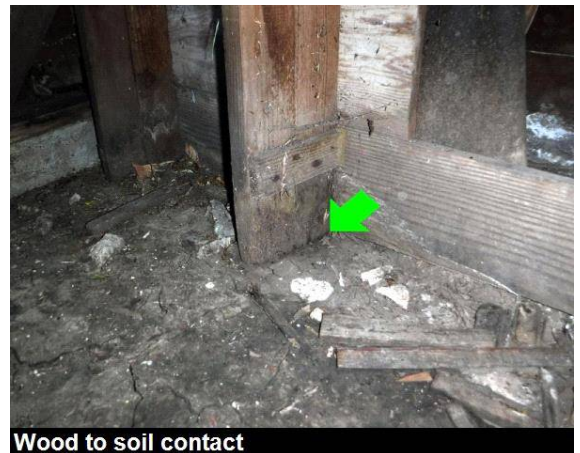
2.2 WOOD DECKING / SURFACES

There is wood-soil contact at several places and we recommend all wood-soil contact be eliminated.

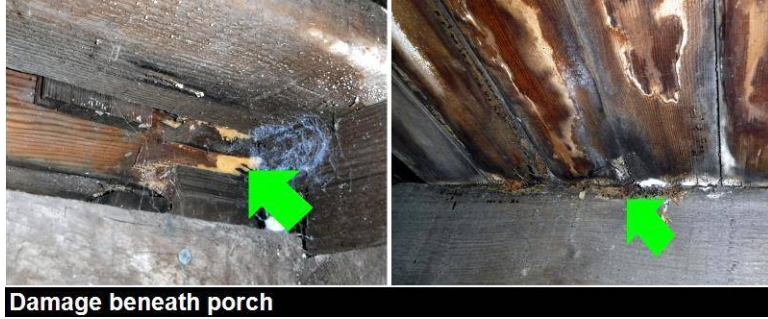
2.3 GENERAL WOOD FRAMING

The decking and framing are damaged at several places. We recommend the damaged wood be examined by a qualified pest control firm. We recommend the damaged wood be replaced. Repair may not be practical and complete replacement should be anticipated. We recommend several contractors be consulted before determining the best solution.

A doubled 2x under the front porch sags, likely indicating it is not sufficient to support the load

above. We recommend repair.

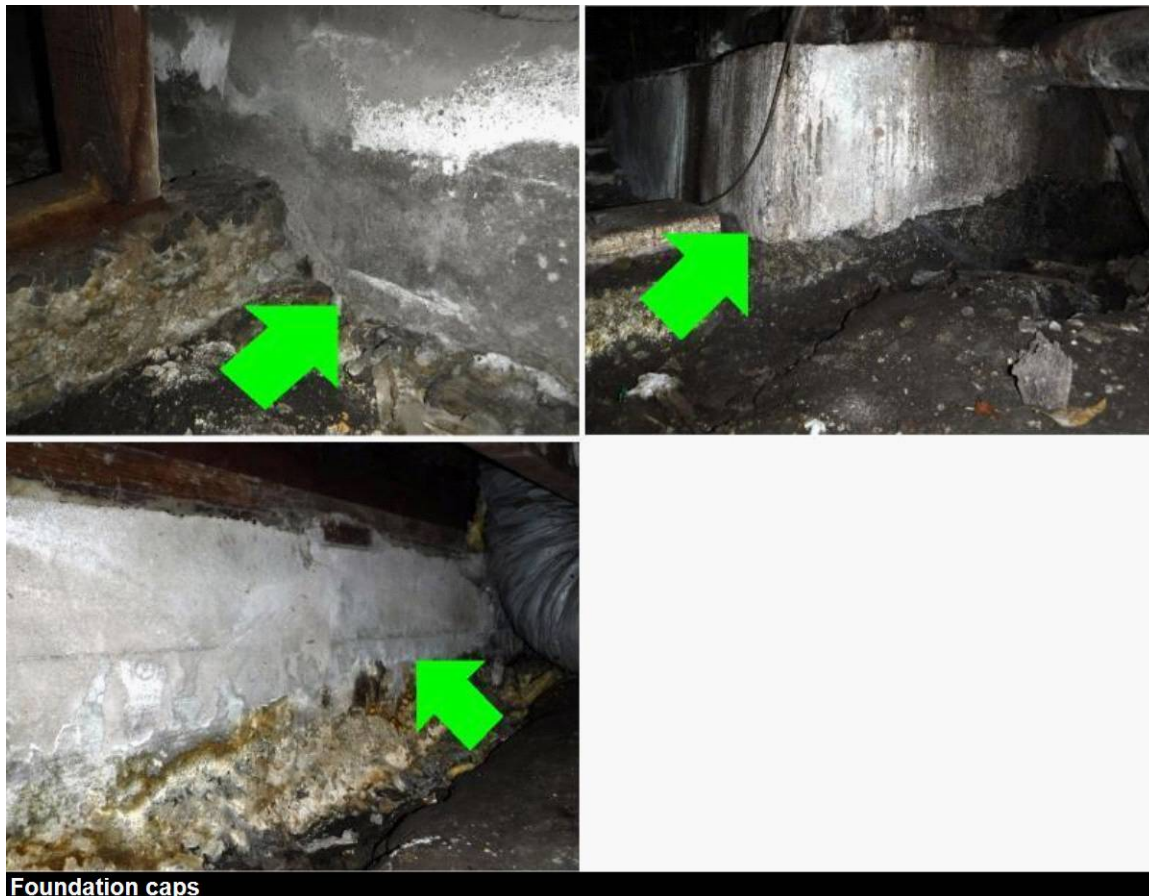
4.5 MODIFICATIONS

Concrete caps have been installed at the tops of several of the foundation walls.

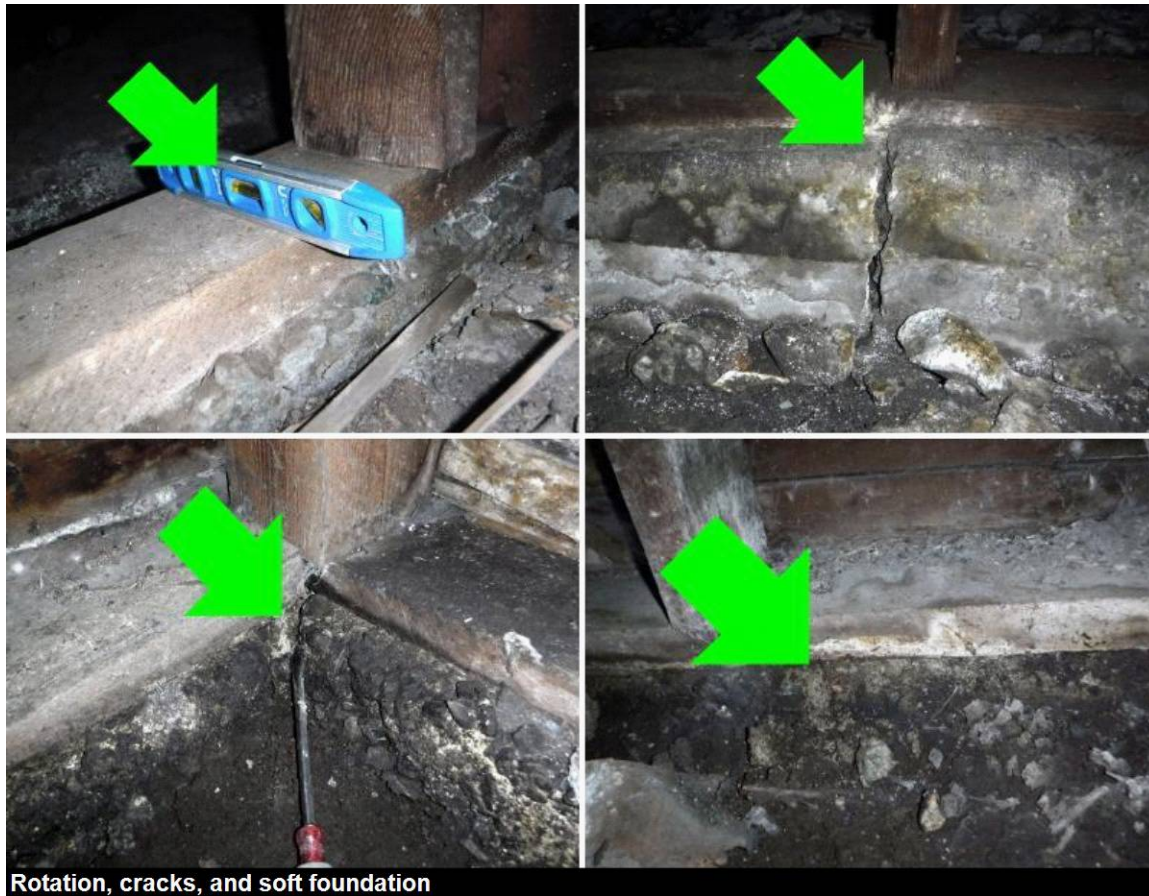
4.6 CONCRETE CONDITION

There are several small, moderate and large cracks in the foundation walls. Some of the cracking appears due to uplift or settling from expansive soils. Improving drainage around the building perimeter may help reduce seasonal movement.

The concrete shows minor surface spalling or surface deterioration at several places.

We observed tilting or "rotation" in one or more of the foundation walls.

We observed efflorescence at several places.

Portions of the foundation appear constructed of a poor quality concrete, which is typical for structures of this age. The need to replace these concrete walls should be anticipated.

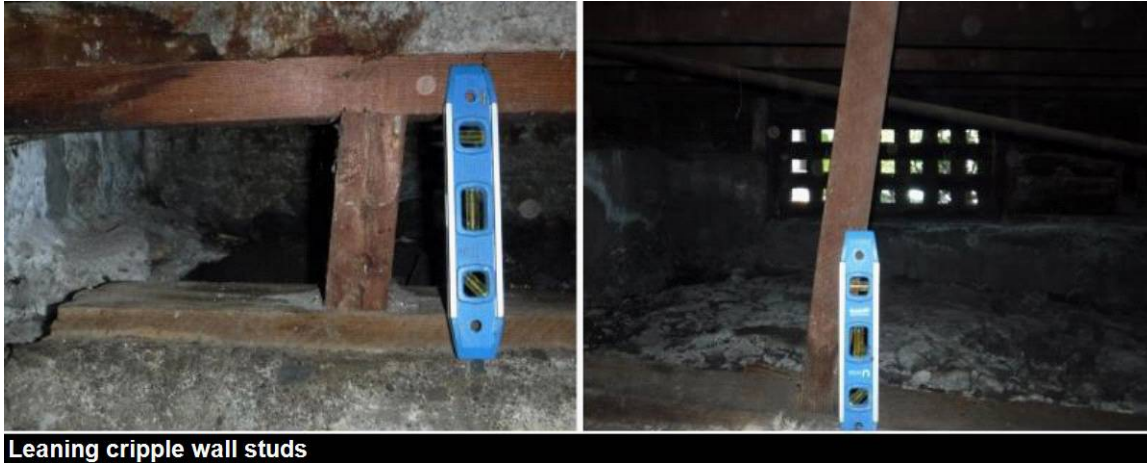
Several cripple wall studs rack or lean, likely due to previous movement. We recommend repair.

Leaning cripple wall studs

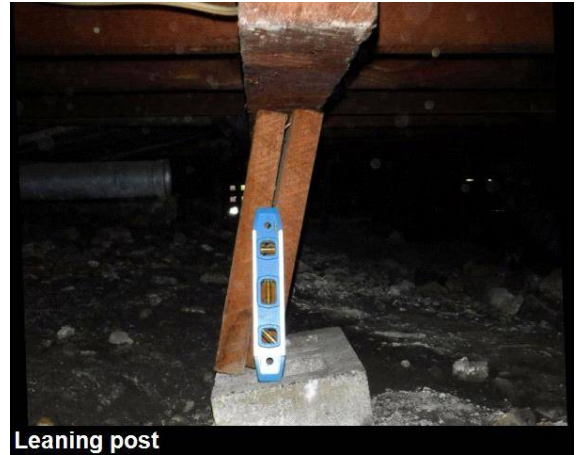
4.12 POSTS AND PIERS

Several supports have been added, apparently to stiffen the floor framing. These temporary supports do not have footings and are not secured in place as would be required for permanent structural supports.

Several of the floor support posts are loose and/or leaning, possibly due to previous soil movement. We recommend they be repaired by a qualified contractor.

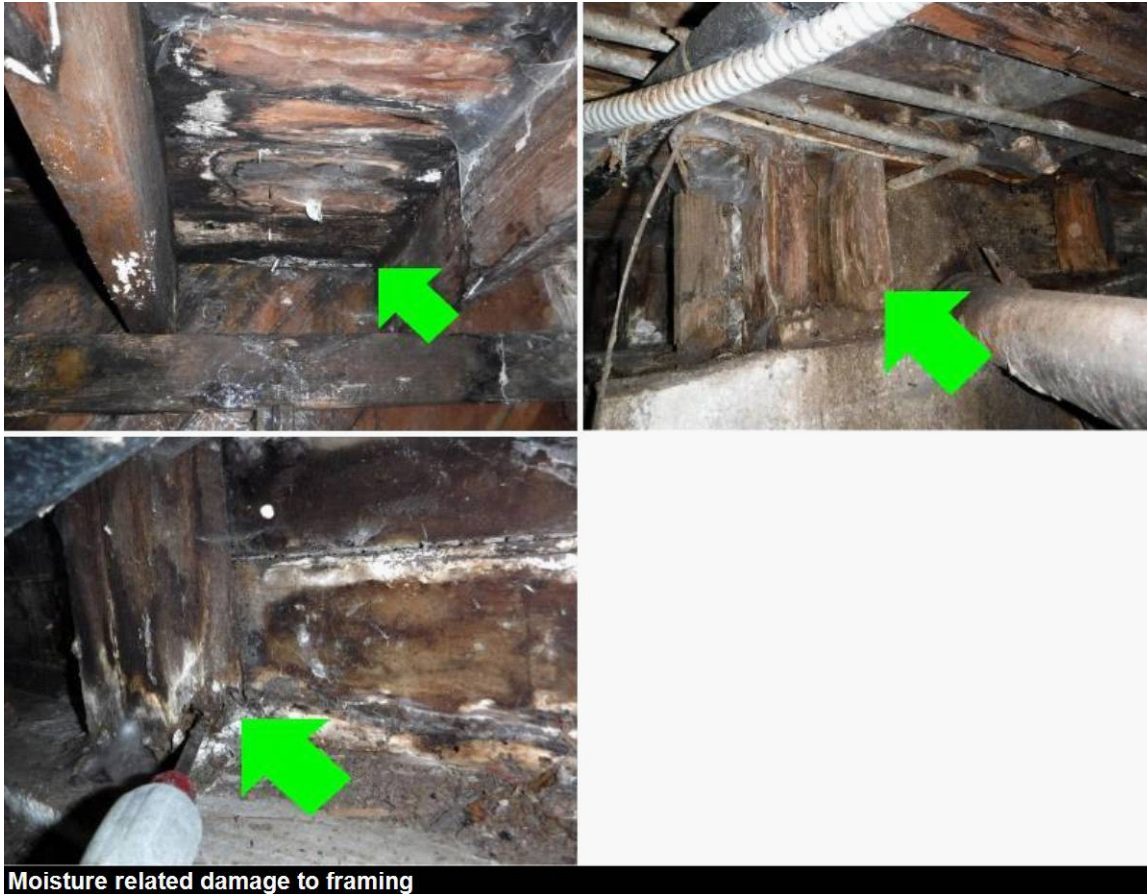
4.15 STAINS, DAMAGE OR PESTS

We observed several stains on the subfloor area framing, apparently indicating previous water entry or leakage. A current pest control report should be consulted concerning the presence of decay or other moisture-related damage.

The subfloor area framing is damaged at many places and we recommend the damaged wood be replaced.

We observed indications of previous wood-destroying pest activity and we recommend a current structural pest report be consulted to determine if active pests are present.

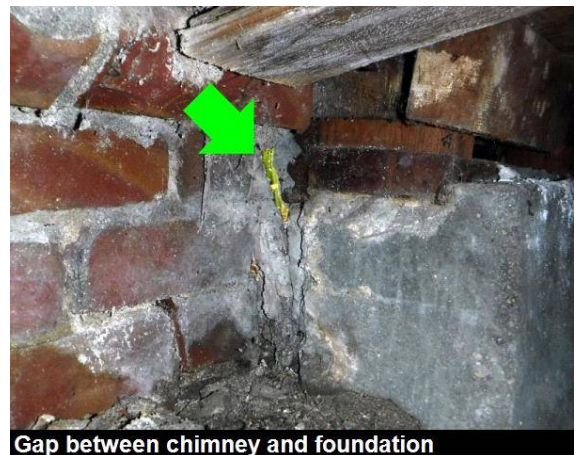
There is a large gap between the chimney and foundation, which may allow pest entry. We recommend repair.

Gap between chimney and foundation

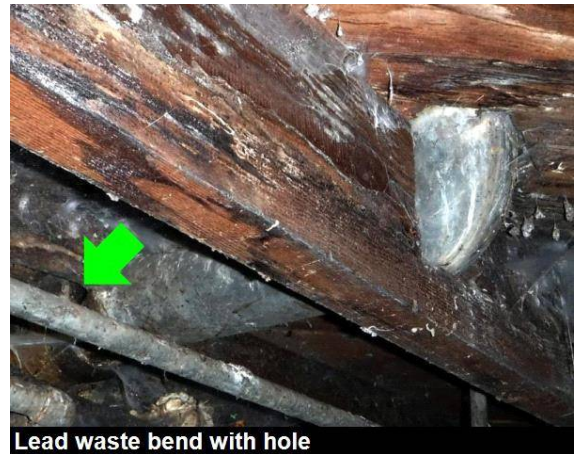
We observed an outdated lead waste drainpipe, or "toilet bend," below the rear bathroom. It is in poor condition and has a hole, which will likely leak. We recommend replacement.

Lead waste bend with hole
