# 4- Point Insurance Inspection Form

1.1 Name: Mr. and Mrs. Owner  
1.2 Address: 123 First Street  
1.3 City: Anywhere  
1.4 County: San Mateo  
1.5 State: CA  
1.6 Zip Code: 94510  
1.7 Inspector: Keith Tarkington, Tarkington Home Inspections, 510-566-2195, inspector@thinow.com  
1.8 Inspection Date: January 15, 2025

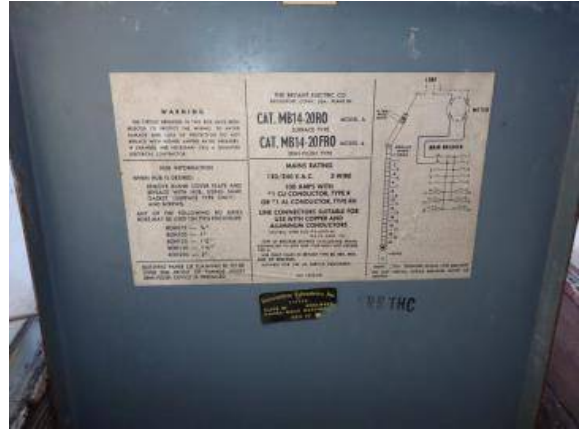
2.7 Panel Label:

2.8 Panel Rating: 100 Amps  
 2.9 Age: Original to house  
 2.10 Panel Ground Observed: Yes  
 2.11 Hazardous Concerns: no cover, corroded  
 2.12 Panel Condition: Unsatisfactory  
 2.13 Photos 1:

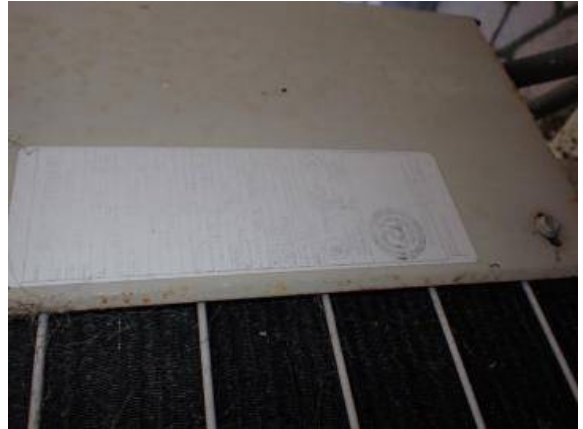
3.14 Manufacturer Label:

3.19 Condition: rusty, disconnected
